NEXCO Technology

The Technology

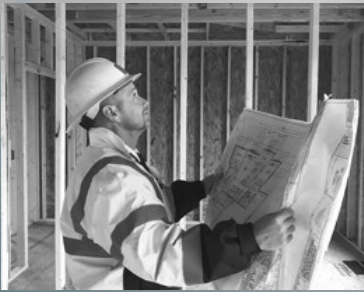
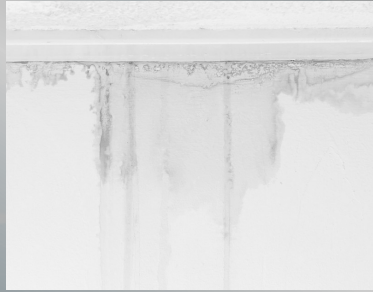
Traditional

- Sketch crack locations by hand
- Long and tedious labor hours
- Surprises from hidden water infiltration
- Take trips back and forth from the site

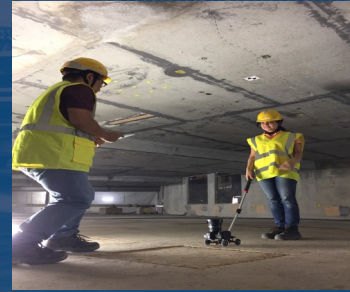
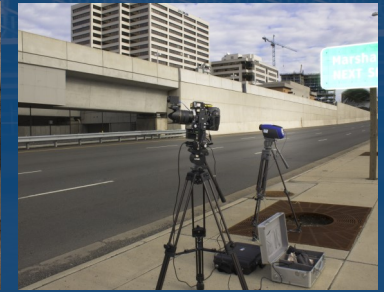
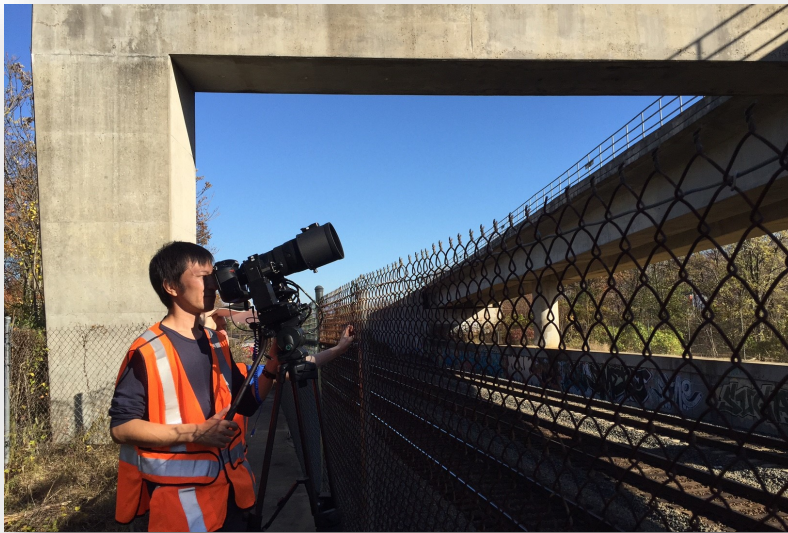
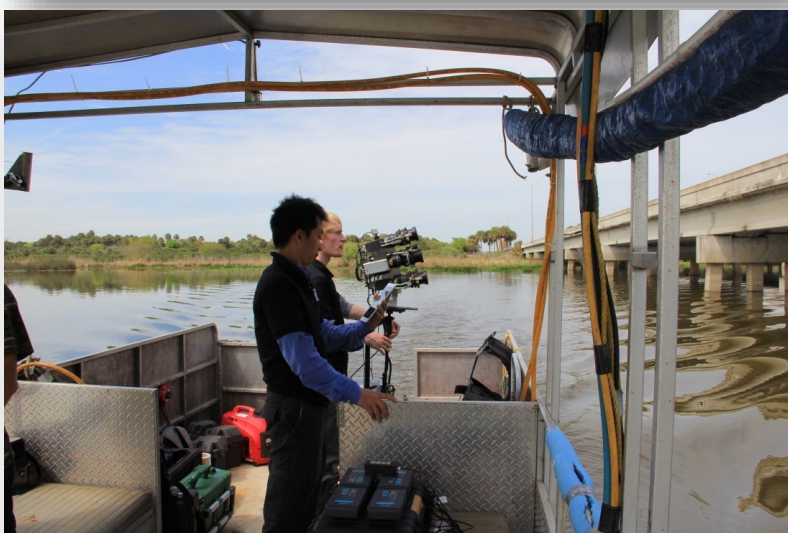
- Map crack location and information
- Broad surface areas captured
- Proactive decision-making
- Have offsite access to comprehensive records

The Automatic Camera System (ACS) and Universal Surface Scanning System (U3S) are perfect applications for taking imagery of dam walls. Both of the platforms can use very high resolution digital cameras to take a picture of the target wall, then integrate the pictures into a map of deficient findings. The map is scaled and can be used to detect cracks at varying resolutions (from 0.2mm and up).

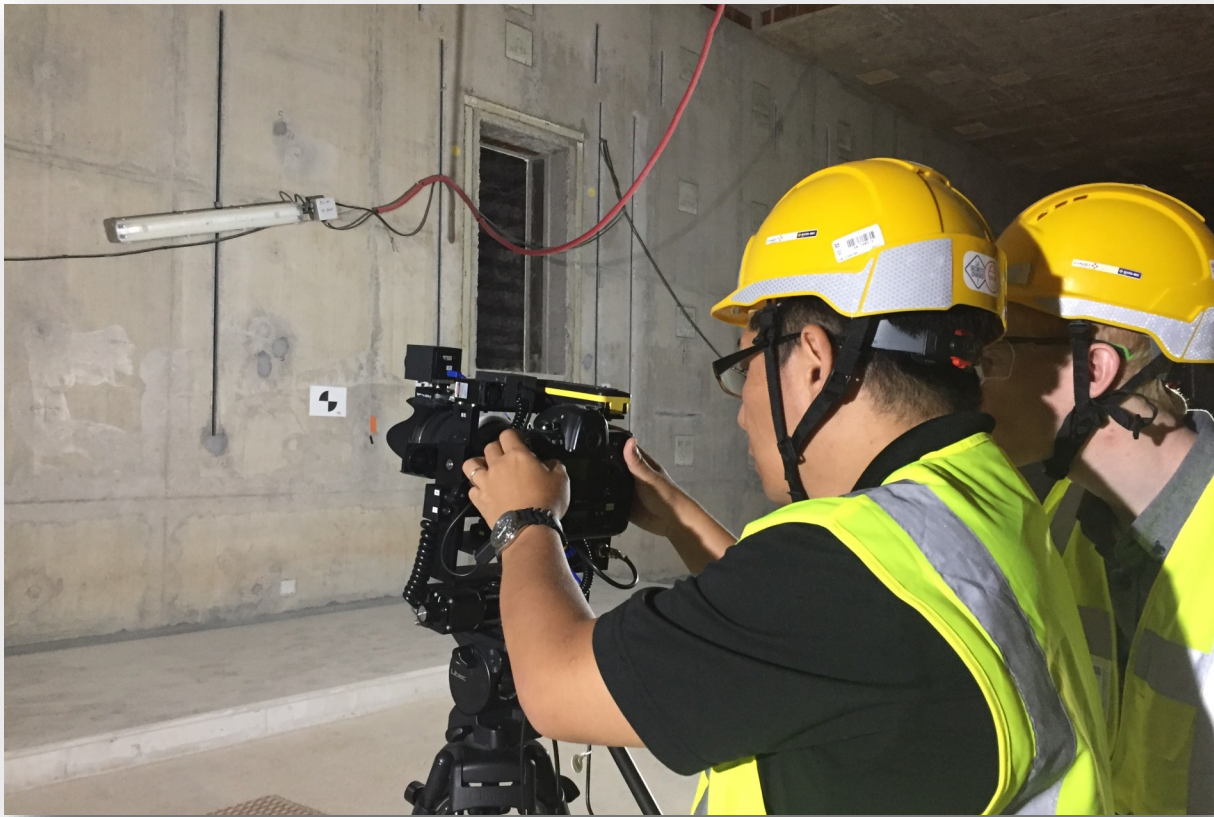
The use of high definition visual and infrared imaging to find and quantify deficiencies in structural surfaces. Storing comprehensive reports and records to make maintenance planning easier!
