Dam Inspection Technology

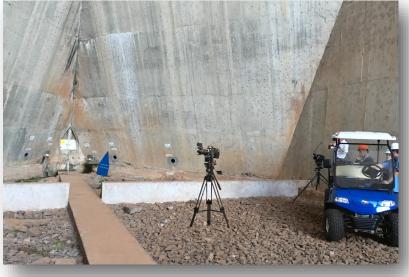
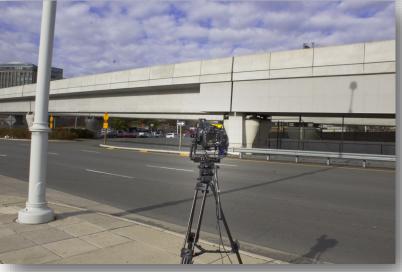
Traditional

Sketch crack locations by hand
Complicated field inspection forms
Long and tedious labor hours
Subjective evaluations

NEXCO Technology

Map crack location and information

Customized forms and reports online

Broad surface areas captured

Proactive decision-making

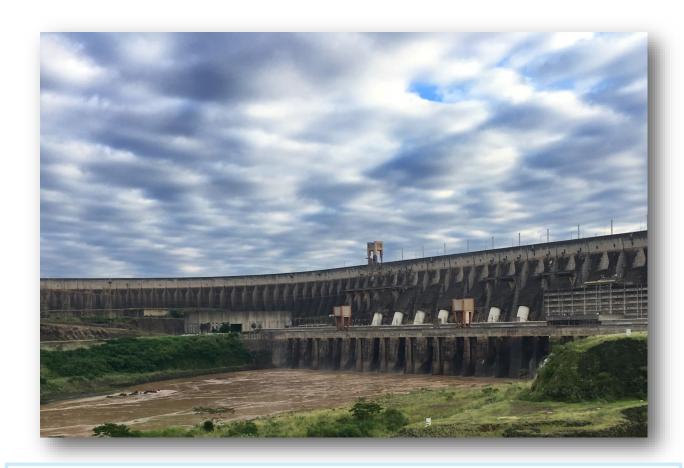
NEXCO's ACS and U3S systems not only image the dam surfaces and preserve digital records but extract detailed information about the location and nature of cracks.

The Automatic Camera System (ACS) and Universal Surface Scanning System (U3S) are perfect applications for taking imagery of dam walls. Both of the platforms can use very high resolution digital cameras to take a picture of the target wall, then integrate the pictures into a map of deficient findings. The map is scaled and can be used to detect cracks at varying resolutions (from 0.2mm and up).

NEXCO supplied the ACS system for a large dam owner so that they may monitor crack propagation over time. The U3S system imaged a set of retaining walls and proximate tunnel surfaces to map water infiltration and major cracking.
